Karst Study Report

23 Hamilton Avenue

ECS Project Number 13:9380

December 20, 2019

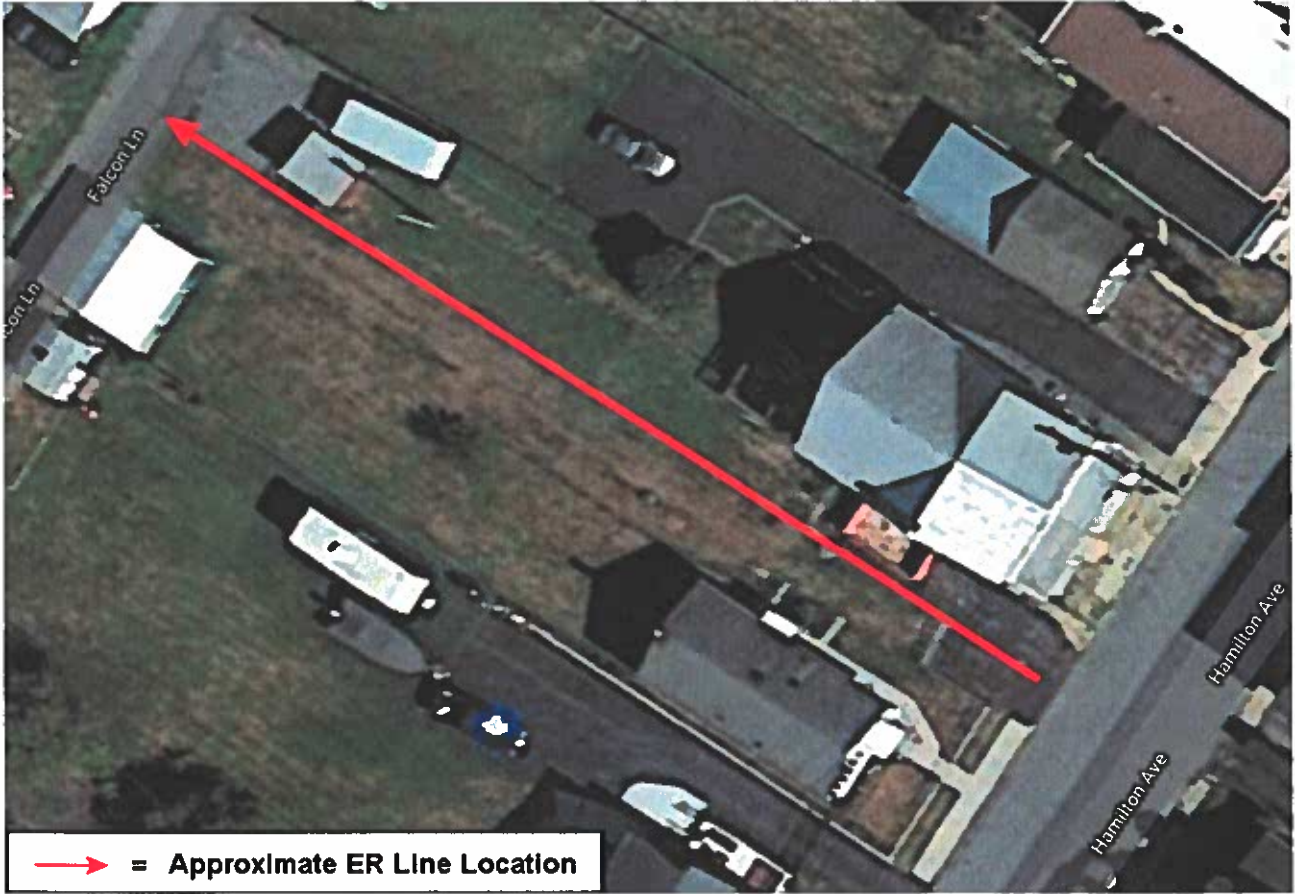
ER LOCATION DIAGRAM  
HABITAT FOR HUMANITY OF FREDERICK COUNTY

→ = Approximate ER Line Location

ECS Mid-Atlantic, LLC performed an ER study as shown on the attached Location Diagram. One (1) ER line was conducted in the test area.

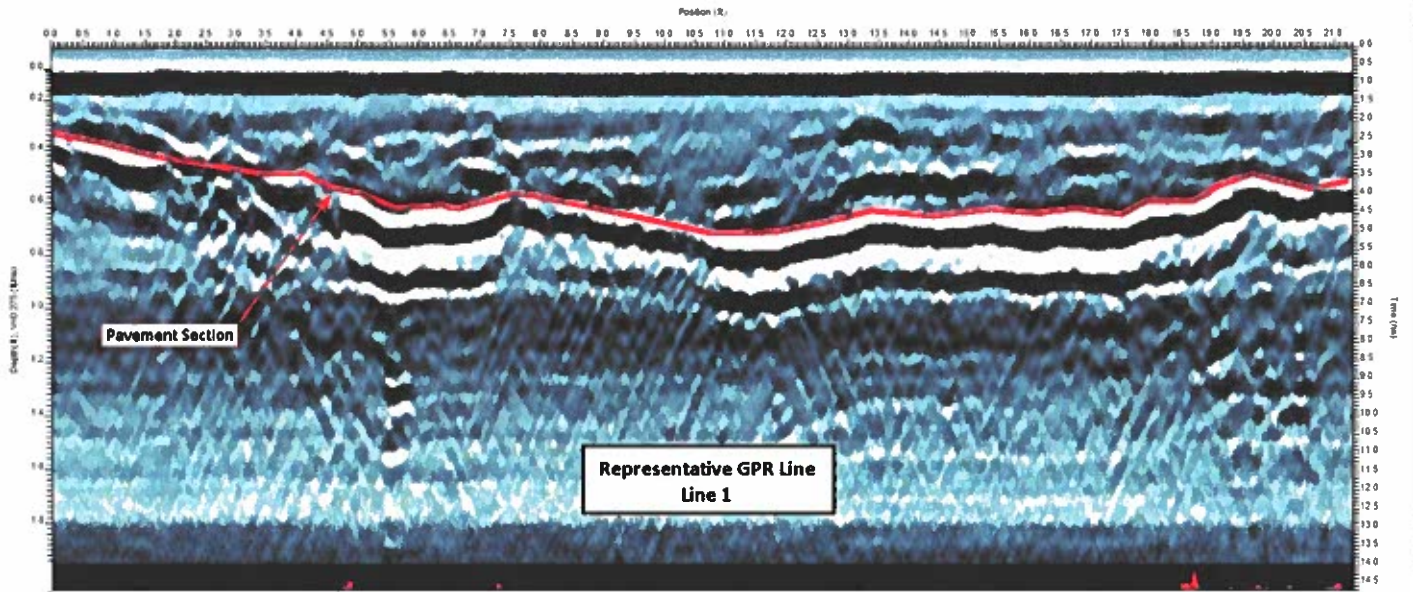
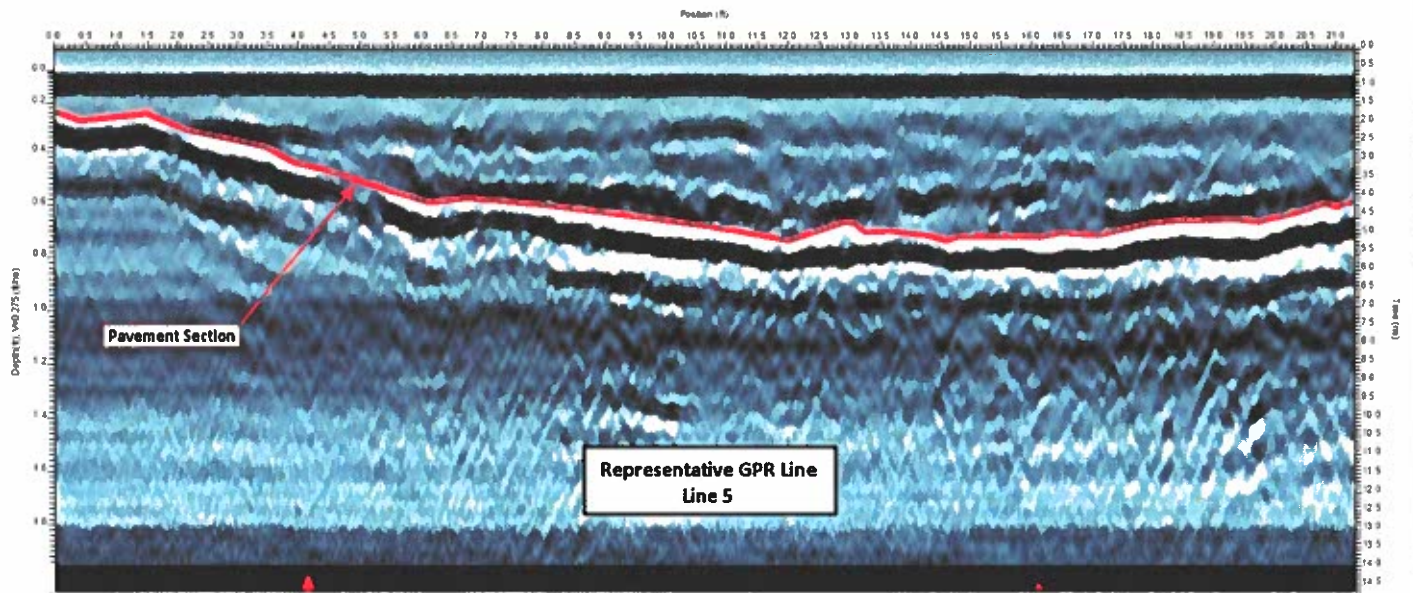
REPRESENTATIVE GPR PROFILES  
1000 MHZ ANTENNA  
HABITAT FOR HUMANITY OF FREDERICK COUNTY

GPR 1000 MHz/LINE0001 Col: 11/04/2019 Freq: 1000 MHz Gain/Filt: Deconv + SEC2 Gain: A/Beta/0.00 21.72 Start Gain: 1.45 Maximum Gain: 54 PCD: 2K

GPR 1000 MHz/LINE0005 Col: 11/04/2019 Freq: 1000 MHz Gain/Filt: Deconv + SEC2 Gain: A/Beta/0.00 24.75 Start Gain: 1.04 Maximum Gain: 86 PCD: 2K

and 8 feet respectively. These antennae were selected in an attempt to locate voids or other subsurface anomalies within the test area with the 1000 MHz antenna used to locate potential voids beneath the asphalt pavement and the 250 MHz antenna to observe conditions deeper in the soil profile. During this study, GPR lines were systematically recorded in approximately 5 foot spacing increments, but varied depending upon surface obstructions encountered.
